Use of Mining Waste in Civil Construction

Pedro Valim Hespanha Gonçalves

Colégio Dante Alighieri, Alameda Fernão Cardim, São Paulo, São Paulo (SP), 01403-020, Brazil; pedro.goncalves@colegiodante.com.br

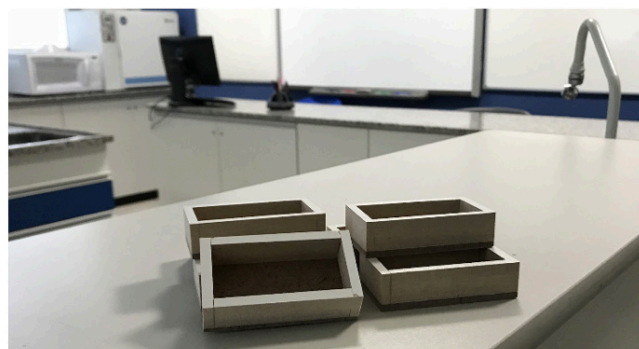
Figure 3: Brick molds made from plywood in the Colégio Dante Alighieri's laboratory.

Bricks with smaller dimensions than ordinary bricks were used in this study to save the mining waste provided by the Samarco industry. Thus, the original measurements of the common bricks were divided by 4, and the following measurements were obtained: height: 1.3 cm, length: 6 cm, and width: 2.9 cm. After the determination of the dimensions, the drawings were sent to the Dante Alighieri College joinery, which made the plywood molds, with a thickness of 0.5 cm (Figure 3).

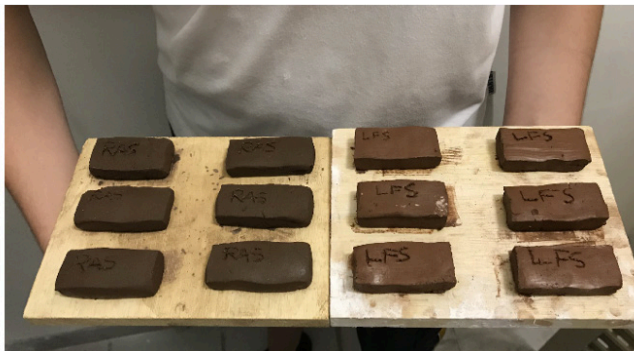
Figure 4: Mini bricks made from Samarco waste. On the left: sandy residue (RAS), and on the right: flotation mud (LFS).

and RAS) were placed in the plywood molds. There were six samples of each type of waste, totaling 12 samples (Figure 4).

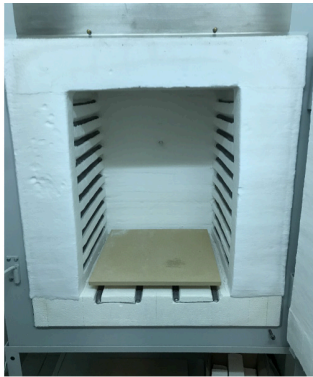
Figure 5: Ceramic material oven from Colégio Dante Alighieri.

All bricks dried for 15 days and were then placed to heat in a ceramic kiln (JUNG, Figure 5). The samples were placed in the oven for eight hours until they reached 900°C. The oven was set to remain at 900 °C for 20 minutes and, after that time, the temperature began to decrease, reaching a final temperature of 40 °C. The total time spent in the oven was 16 hours.

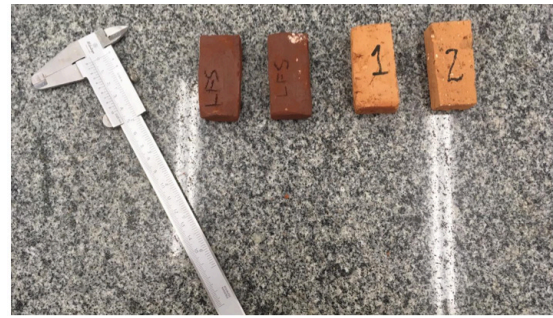
Figure 8: Waste bricks and common bricks after cutting in the civil engineering laboratory at PUC-SP.

Firstly, the commercial bricks were cut in the cross-section to have the same dimensions as the mini waste bricks using an AEG Policorte saw, model SMT-355 (Figure 7). The cut bricks can be seen in Figure 8.

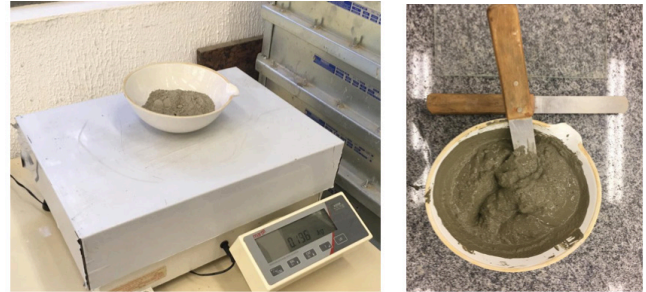
Figure 9: Cement being weighed on the scale and the cement mass prepared after adding water.

To carry out the compression test, following the previously mentioned standard, 300g of cement (CP II-E32) were weighed on a scale (Mars - AD50K) and mixed with 150 ml of water until a homogeneous paste formed, which was deposited in a porcelain capsule (Figure 9).

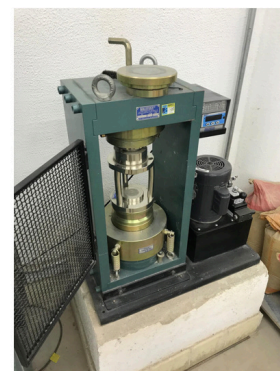
Figure 11: Hydraulic press used for brick compression tests (brand: Solotest).

The material was entirely covered by the prepared cement. After that, the bricks dried for 14 days so that it could be tested on the hydraulic press (Figure 11).

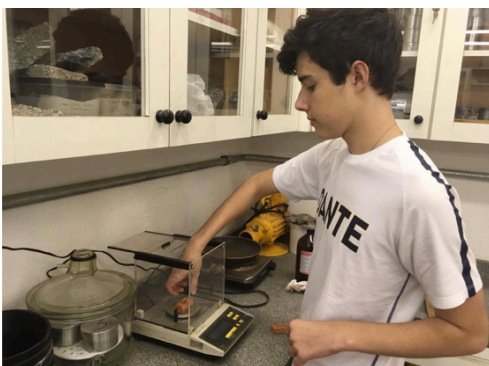
Figure 12: Determination of the mass of bricks in PUC-SP laboratory analytical balance.

The water absorption test was also performed following the ABNT NBR 8492 standard. First, the brick mass was determined before and after placing it in a drying oven (Figure 12). Then, the samples were immersed in water (Figure 13), and after twelve hours, the mass of the wet block was measured. The percentage of water absorbed by the sample was determined by the difference between the two values found. At the end of the analysis, the brick was required to have a water absorption between 8% and 25%.¹⁴
